NATIONAL TRANSPORTATION SAFETY BOARD

Investigator-in-Charge Factual Report

Type: Collision

NTSB #: DCA19FM033

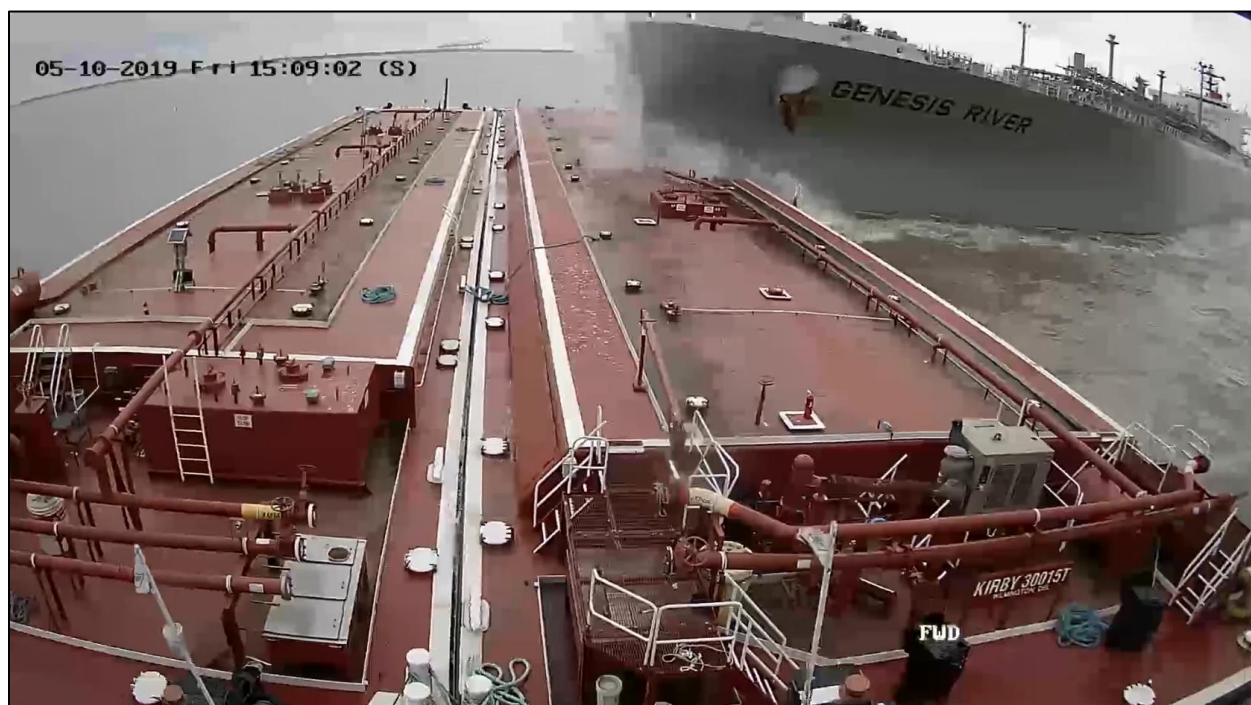
Figure 1. Screen capture from wheelhouse video on board the *Voyager* at the moment that the *Genesis River* struck barge 30015T. (Source: Kirby Inland Marine, LP)

At 1516:09, the *Genesis River*'s bow struck barge 30015T, breaching the number 2 cargo hold on the starboard side near the longitudinal center of the vessel and continuing through the hull into the number 2 cargo hold on the port side. The force of the collision capsized barge *MMI3041*, although no tanks were breached. When the *Genesis River* impacted the 30015T, the port face and long wires securing the *Voyager* to the barges parted. As the barges were pushed sideways by the *Genesis River*, the *Voyager* pivoted on the starboard face wire until the towing vessel's starboard side contacted the stern of the 30015T. As the *Voyager* continued to be pulled, it heeled to starboard until the starboard face and long wires gave way allowing the relief captain

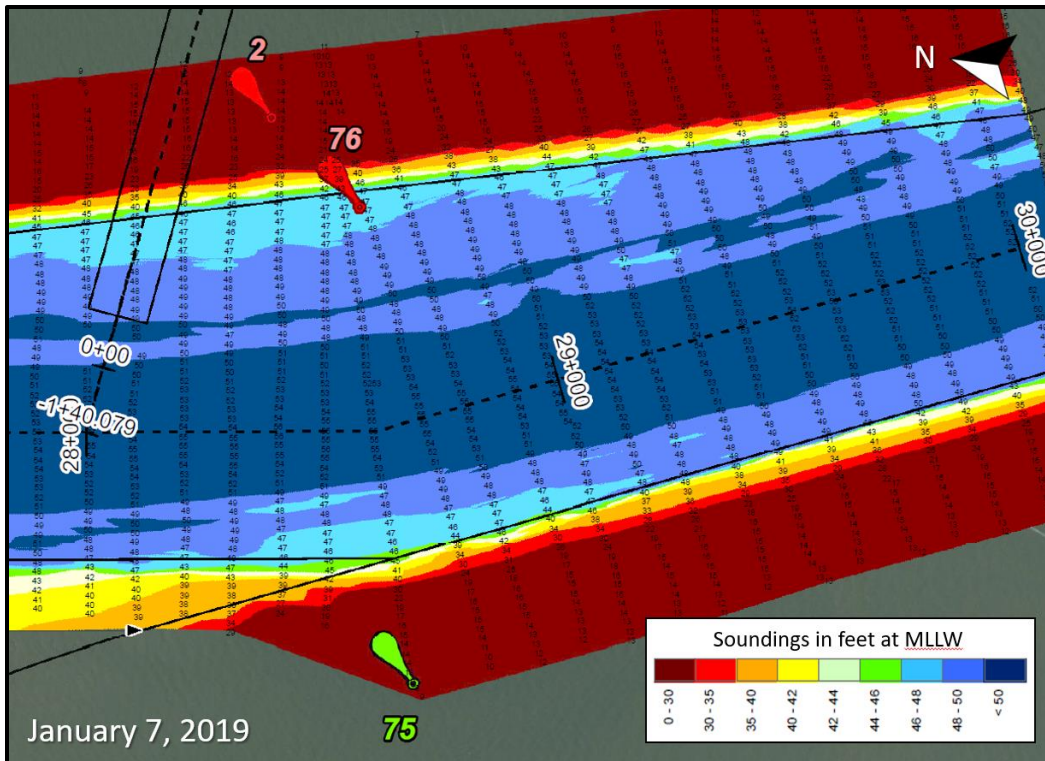
The Army Corps of Engineers is responsible for maintaining the Houston Ship Channel at its authorized width and depth by conducting periodic dredging operations. The frequency of dredging varies, with areas that historically shoal at a faster rate being dredged at shorter intervals. A Corps of Engineers representative stated that the periodicity of dredging is also dependent on available funding. Dredging plans are updated as needed based on regular depth sounding surveys of the channel. Surveys are conducted at intervals not less than 6 months and can also be requested on an ad hoc basis by the Coast Guard, the Houston Pilots, or other users of the channel. Figure 7 below shows the January 2019 periodic survey results for the turn at Five Mile Cut. Blue tones indicate deeper water, while yellow/red tones indicate shallower water. The sounding data in feet are indicated by the numbers in the image. Figure 8 shows the results of a survey that was requested by the Houston Pilots immediately following the accident in May 2019. Note that the May survey shows some shoaling had occurred in the turn in the 4 months since the January periodic survey.

Figure 7. January 2019 sounding survey data for the Houston Ship Channel at the turn at Five Mile Cut. (Source: Army Corps of Engineers)

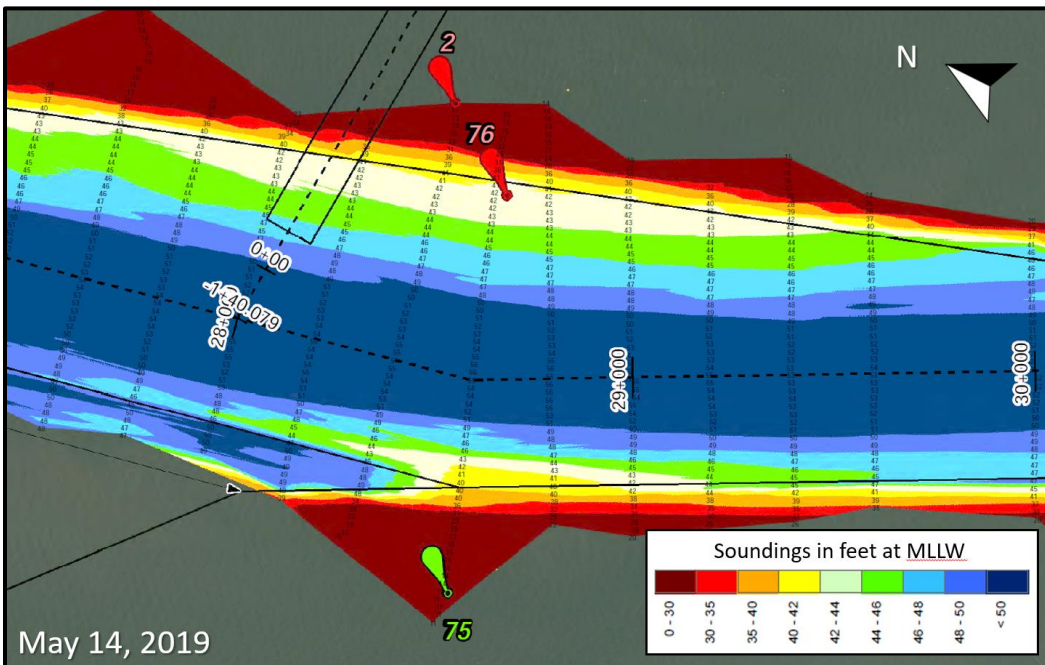
Figure 8. May 2019 sounding survey data for the Houston Ship Channel at the turn at Five Mile Cut. (Source: Army Corps of Engineers)

When asked by investigators, a Corps of Engineers representative confirmed that shoaling was common in turns of the channel. She also stated that the area of the channel in the vicinity of

the Bayport Flare and just south of the flare was prone to shoaling, but that it was “not one that is commonly brought up as a concern.” Prior to the accident, the channel in the vicinity of the turn at Five Mile Cut had last been dredged in late 2017. In November 2019 (5.5 months after the accident), planned maintenance dredging of the Houston Ship Channel in this area commenced.

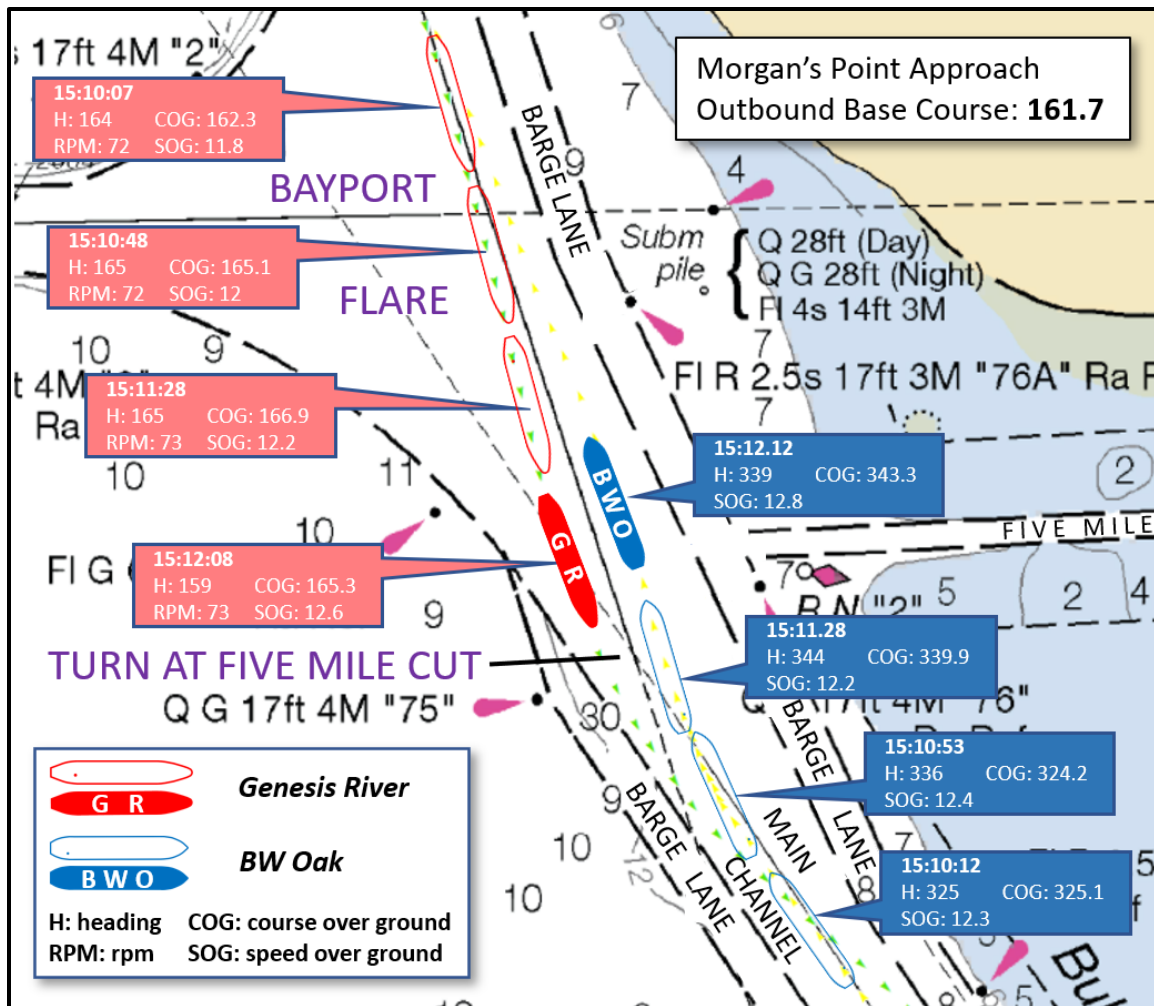
Figure 9. *Genesis River* and *BW Oak* passing in Bayport Flare. Positions based on automatic identification system (AIS) reporting data from each ship. (Background adapted from NOAA chart 11327)

At 1511:48, pilot 2 ordered port 15 degrees rudder, and the rudder moved to the ordered angle as the bow of the *Genesis River* passed the bow of the *BW Oak*. Nine seconds later, the pilot ordered rudder midship, followed almost immediately by hard starboard rudder. The helmsman repeated the command, and the rudder moved to starboard 35 degrees at 1512:07. A second later, pilot 2 ordered the rudder eased to starboard 10 degrees, followed another 2 seconds later by an order to rudder midship. The rudder began moving to midship, reaching centerline at 1512:20 just as the stern of the *Genesis River* passed the stern of the *BW Oak*. During this 32 second period, the *Genesis River*'s heading shifted 8 degrees to port, to 158 degrees.

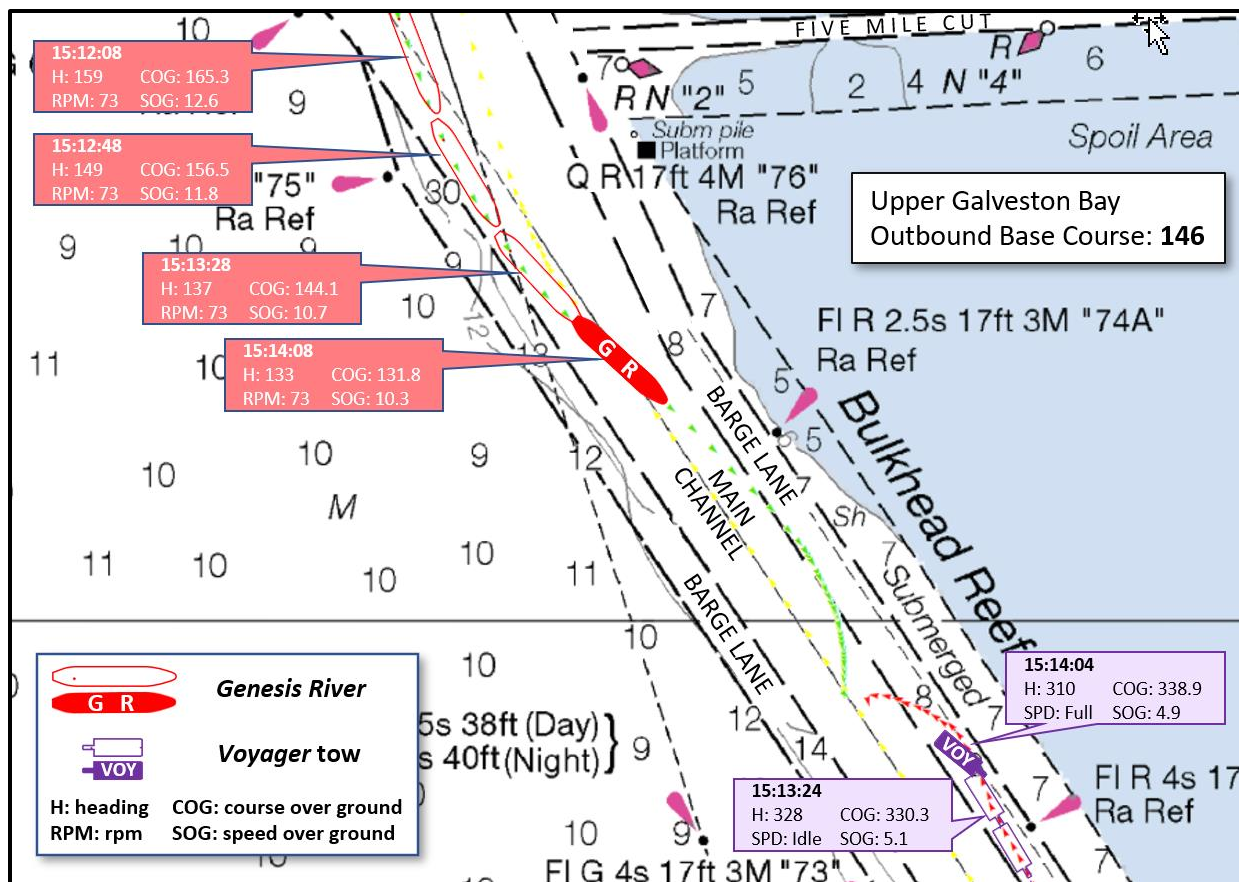
Figure 10. *Genesis River* crosses the channel as *Voyager* tow begins to turn to port. (Background adapted from NOAA chart 11327)

Meanwhile, as the *Genesis River* crossed the center of the channel toward the red side (with the water depth under the keel increasing to 5 meters), the ship's swing to port slowed and then ceased at a heading of 132 degrees. In response, pilot 2 ordered the rudder to midship, followed immediately by an order of rudder hard to port. The vessel held the 132 heading for 10 seconds, before it began swinging back to starboard, slowly at first, starting at 1514:06. The *Genesis River*'s rudder swung from starboard to port, reaching 22 degrees to port before pilot 2 issued his next order. At 1514:13, the pilot ordered the rudder to midship, then to starboard 20 degrees. Five seconds later, he ordered the rudder increased to hard starboard. The rudder swung back again to starboard, reaching 34 degrees at 1514:24.

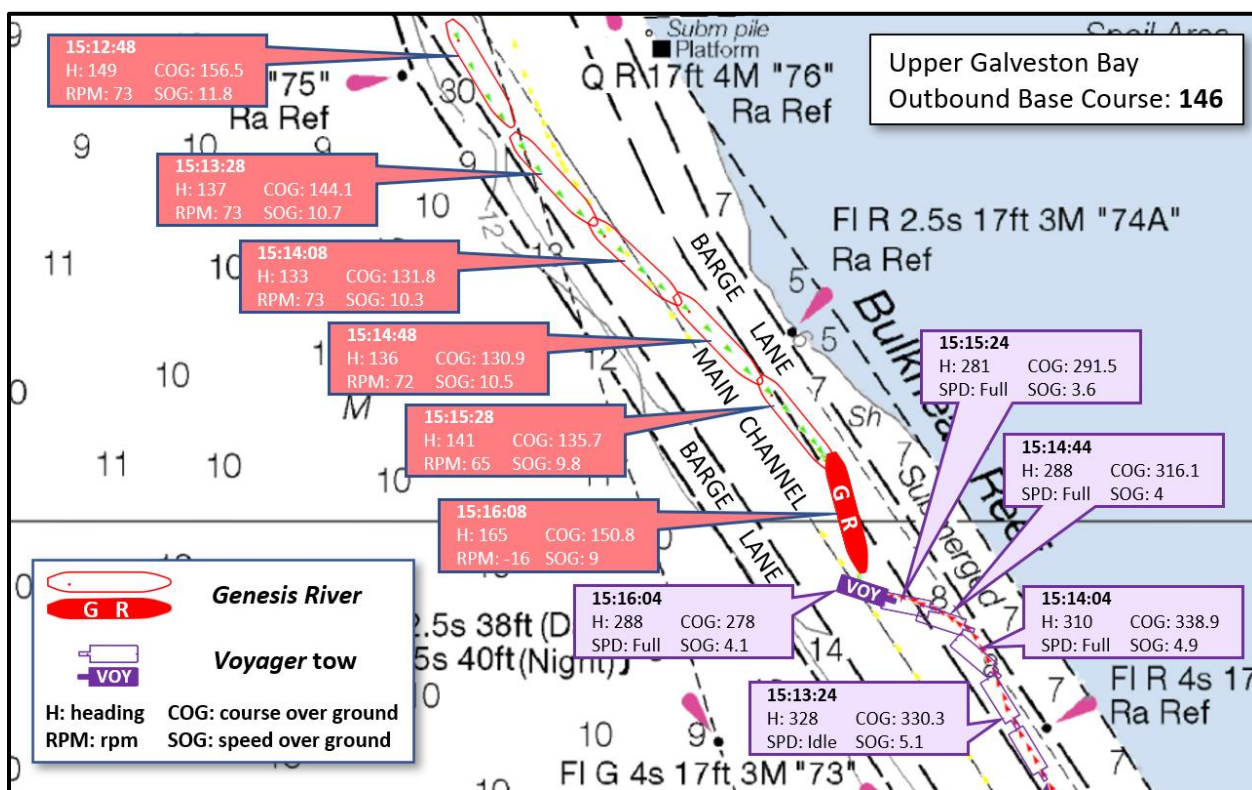
At 1515:35, with the *Genesis River* swinging back toward the *Voyager* and its tow, the second officer said to pilot 2, “hard port, sir, hard port.” He received no reply. Eight seconds later, the pilot ordered “stop engines.” The master, who had returned to the bridge, repeated the engine order to the second officer. At 1515:49 and again at 1515:52, the sound of the engine order telegraph alarm was recorded by the VDR. After the second alarm, the rpm demand signal went to zero, and the engine rpm began to slow quickly. At 1516:03, seconds before the collision, the master ordered the engine to “crash astern” (on the *Genesis River* EOT, crash astern was called “Emerg. Full.”) The crash astern input to engine control system overrode the normal control program and executed an accelerated shift to maximum astern propulsion.

Figure 11. *Genesis River* and *Voyager* seconds before to collision. (Background adapted from NOAA chart 11327)
